Mooring Ropes Retirement Guidelines – Timm Master 8 / 12SBA

1. Introduction

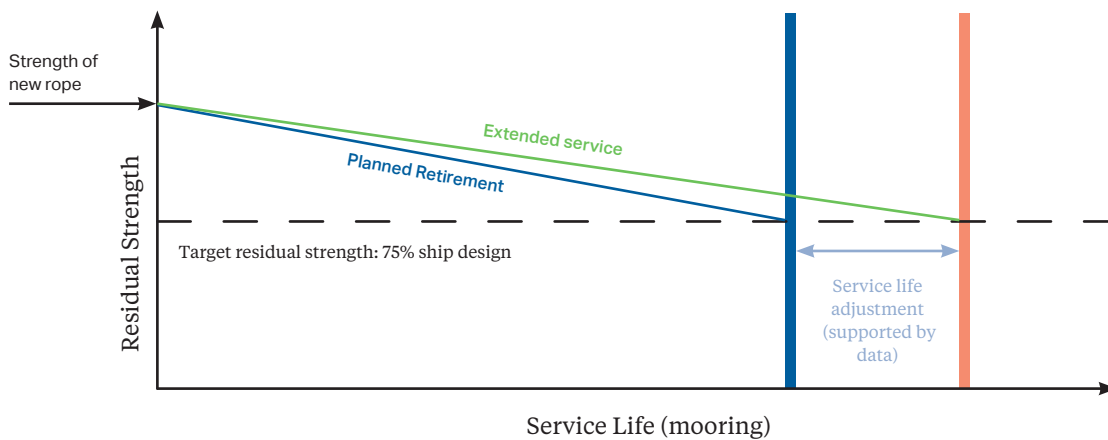
Service life adjustment according to OCIMF MEG4

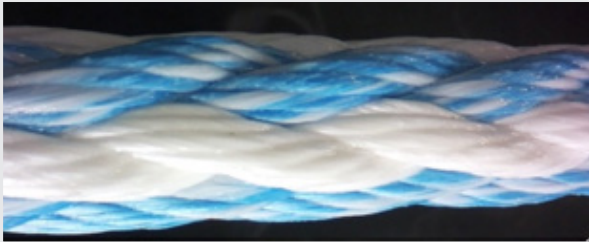
Fibers intact, no visible external damage.

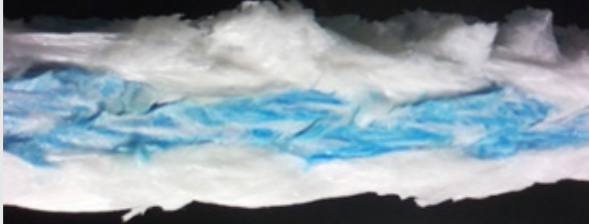
Abrasion clearly visible on more than 10% of cross section of the rope. Rope must be retired.

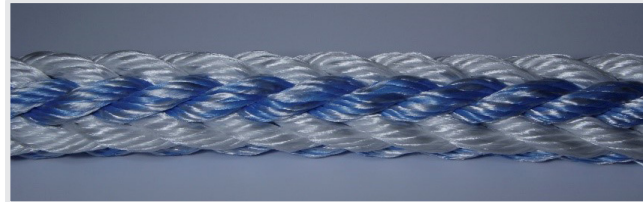
<p>Fibers intact, no visible cuts .</p>

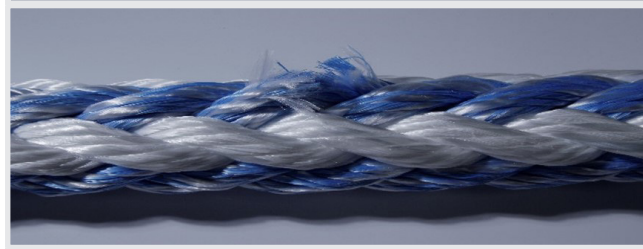
<p>Visible cut in fibers. Less than 8% of total amount of yarns. Recommend monitoring the rope, inspect and find sharp edge in the path of the rope causing the cut and repair. Protect the rope.</p>

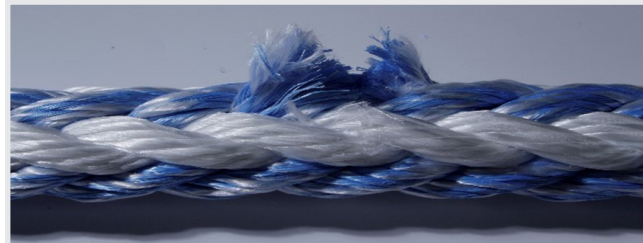
<p>Cut yarns clearly visible on more than 8% of total amount of yarns in whole rope. Rope must be retired. Inspect and find sharp edge in the path of the rope causing the cut and repair. Protect the new rope.</p>

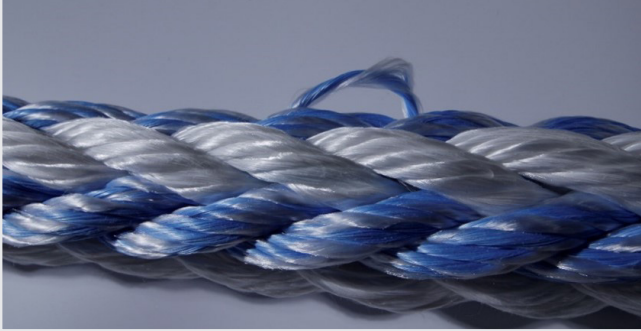
<p>Minor damage. Hide the fibers inside the rope. Inspect and find the obstacle causing the pulled yarns and remove or repair.</p>

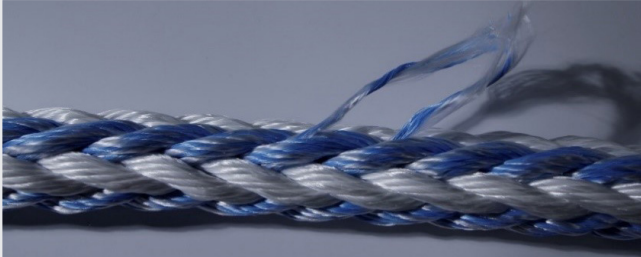
<p>Pulled yarns can be repaired by working the yarns into the rope or cutting off close to the rope surface. Inspect and find the obstacle causing the pulled yarns and remove or repair.</p>

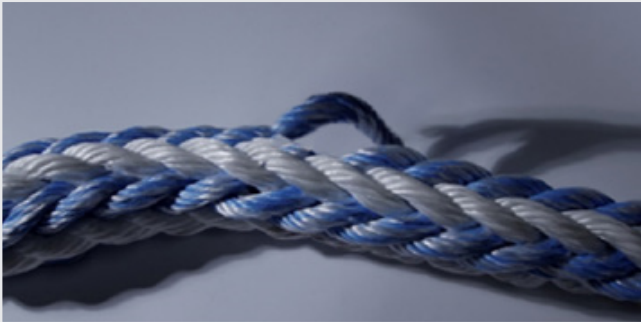
<p>Pulled strand can be repaired by working the strand into the rope by locating the damage on the length of the rope and by pulling and settling the strand. Inspect and find the obstacle causing the pulled strand and remove or repair.</p>

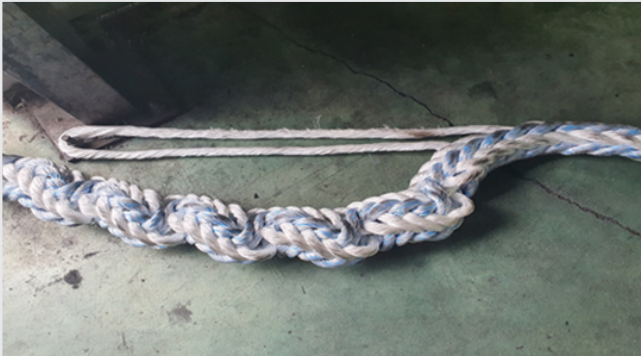
<p>Pulled strand caused major constructional damage on rope's length. Ropes must be retired. Inspect and find the obstacle causing the pulled strand and remove or repair.</p>

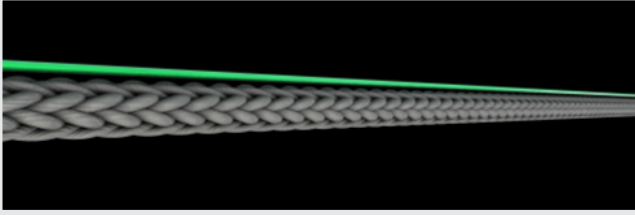
No twist. Perfect conditions.

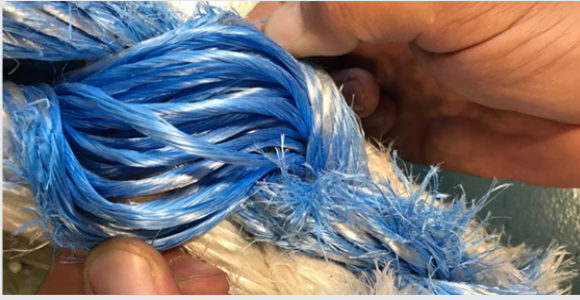
UV degradations visible by crushed fibers. Rope must be retired.

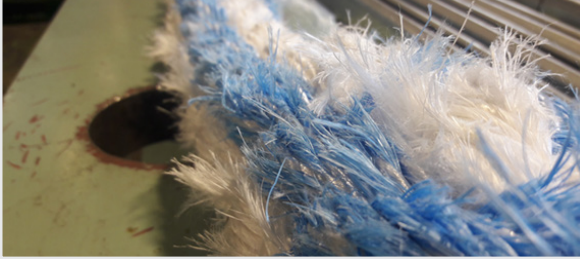
UV degradations visible by crushed fibers. Rope must be retired.

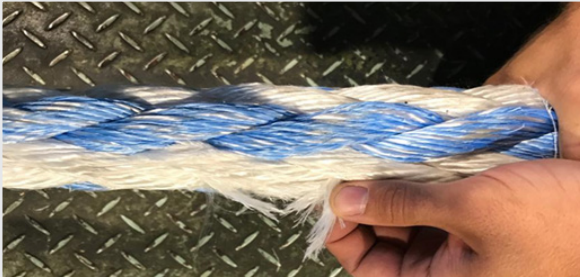
Yarns easily crushed or damaged by hand. Rope must be retired.

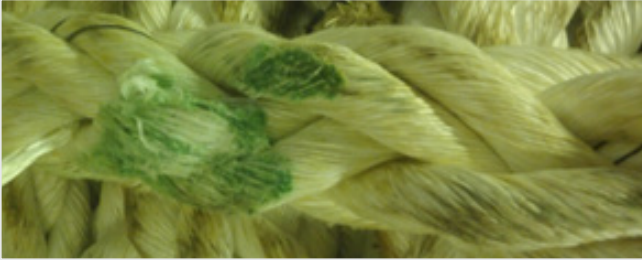
Rope log shows that there has been significant exposure to chemicals. Rope must be retired.

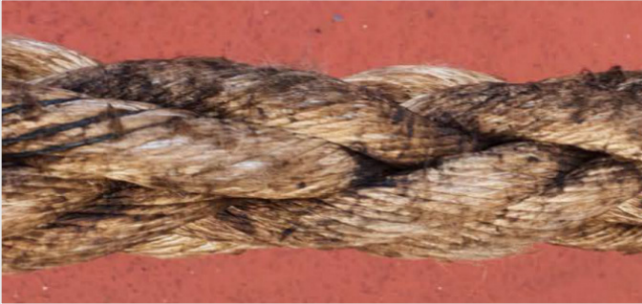
Rope discoloration, brittle fibers, fusion, bonding of fibers, hardness. Chemical exposure suspected. Rope must be retired.

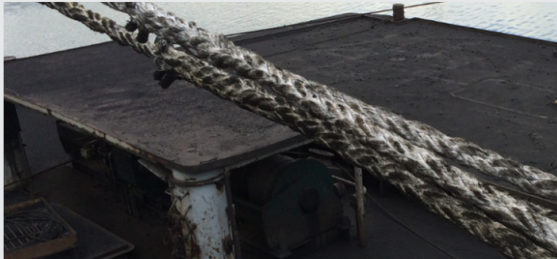
Rope and deck/floor dirty. Recommended to inspect regularly for internal and external abrasion.

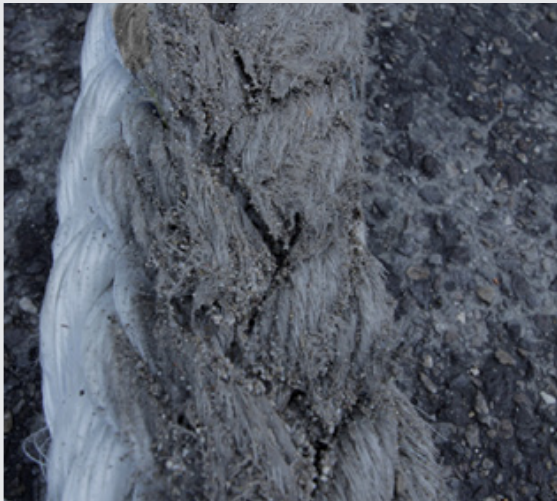
Dirt in the rope structure, broken fibers. Internal and external abrasion. Rope must be retired.
